# Health & Safety Risk Assessment – Amenities Only.

Address of premises:	17-25 Valleyside Swindon SN1 4NB
Responsible Person:	Valleyside Management Company Ltd
Duty Holder:	Block Management Ltd
Person(s) consulted:	No occupier or other relevant person available to consult.
Assessor:	Josh Godfrey, TIFireE.
Report validated by:	John Godfrey, GIFireE.
Date of fire risk assessment:	11 <sup>th</sup> September 2024/ Reviewed September 2025
Date of previous fire risk assessment:	Not known
Suggested date for review:	September 2026

<b>GENERAL INFORMATION</b>		
<b>1.0</b>	<b>THE PREMISES</b>	
1.1	Number of Floors	N/A
1.2	Approximate floor area in m2:	N/A
1.3	Brief details of construction and layout:	This residential development comprises of 12 independent units. The ground floor contains garages, the first floor contains 6 units and the second floor decks access 6 units.

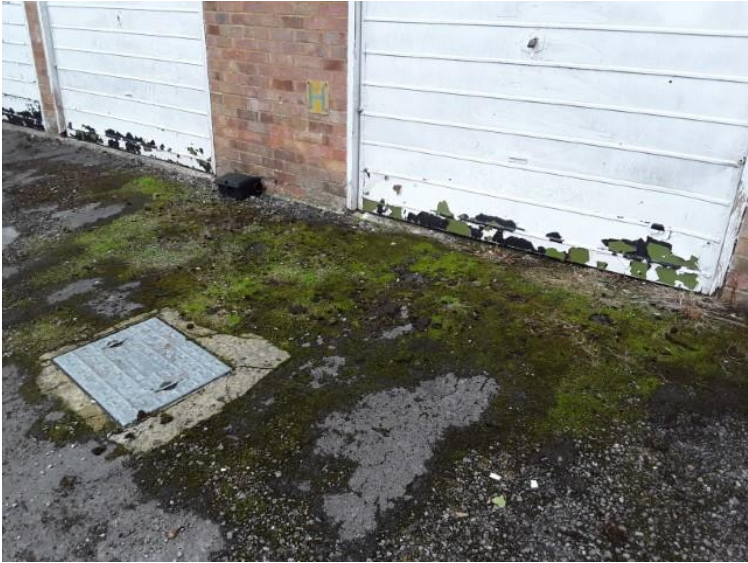
ACTION PLAN				
Action	Detail (to be read in conjunction with the report findings)	Priority	Action by whom	Date action undertaken
01	<p>It was noted during this assessment that there is a buildup of moss outside the garages. It is recommended that all moss be removed in order to reduce the risk of a trip or a slip occurring.</p>

8.2	Comments and hazards observed:	
	<p>It was noted during this assessment that there is a buildup of moss outside the garages. It is recommended that all moss be removed in order to reduce the risk of a trip or a slip occurring.</p> <p>Grit / Rock Salt storage should be subjected to an separate risk assessment to include a COSHH assessment and a material safety data sheet for any hazardous materials should be obtained. Regular checks should be made to ensure the grit is useable and sufficient quantities are stored prior to any anticipated cold weather. Hand shovels should be provided for grit dispersal.</p> <p>It was noted during this assessment that in order to escape from the second floor decks units 19a, 19, 23 and 24 need to be passed in order to reach a place of total safety. It is therefore recommended that these doors be replaced with FD30 doors which should be complete with three grade 13 hinges and overhead self-closing devices in order to adequately protect the means of escape.</p>

MED	Client	<p>Ongoing action required</p> <p>Contractor to remove moss as appropriate.</p>
02	<p>It was noted during this assessment that in order to escape from the second floor decks units 19a, 19, 23 and 24 need to be passed in order to reach a place of total safety. It is therefore recommended that these doors be replaced with FD30 doors which should be complete with three grade 13 hinges and overhead self-closing devices in order to adequately protect the means of escape.</p>
